## ***ArmaKleen Technical Service Report Summary***

**Cleaning Trial Type:** Calcium and Paint Removal

**Description of Part(s):** 5" diameter steel connector and a 10"x8" steel t-pipe with connector

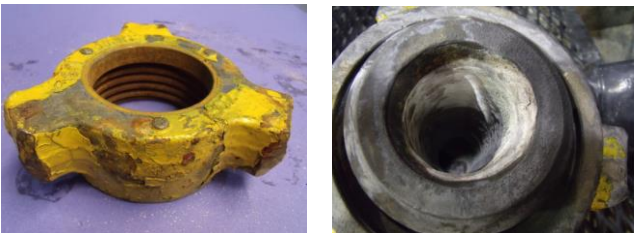
### **Before Picture**

**Soil:** Grime, grease, calcium build up, paint

**Recommendation to Customer:** The ArmaKleen Technical Center recommended using for paint removal 100% by volume ArmaKleen™ Paint and Ink Remover at 160°F in an Agitating Immersion Washer for a minimum of 2 hours. The ArmaKleen Technical Center recommended using for calcium removal 20% by volume ArmaKleen™ Rust Remover at 160°F in an Agitating Immersion Washer for a minimum of 4 hours.

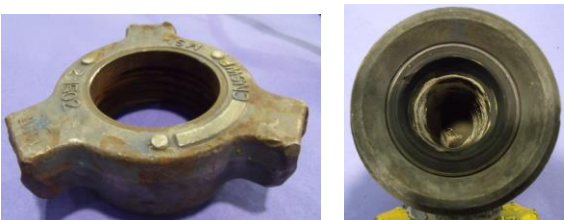
### **After Picture**

**Post Cleaning:** Fresh water rinse followed by air pressure drying. Light brushing with a stainless steel brush was used during the rinsing of the paint removal step.
