ArmaKleen Technical Service Report Summary

Cleaning Trial Type: Paint Removal

Industry: Helicopter Repair and Remanufacturing

Description of Part(s): 8.75" x 17" magnesium and aluminum housing unit

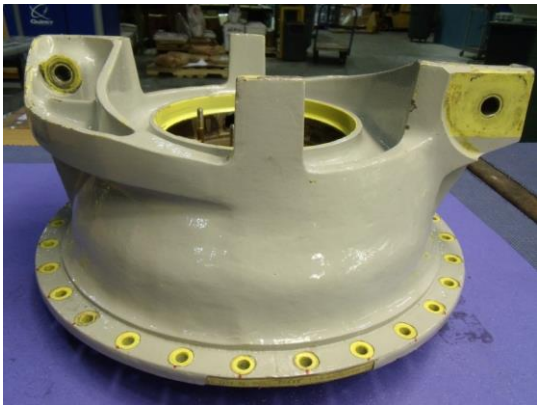
Before Picture

Soil: Polyurethane paint

Substrate: Magnesium and aluminum

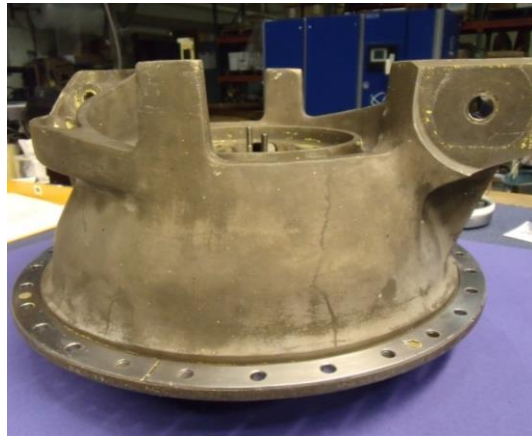
After Picture

Cleaner used: 100% by volume ArmaKleen™ Paint and Ink Remover

Machine used: Agitating Immersion Washer (81.8, T12, T24)

Temperature used: 160°F

Time required: 6 hours

Post Cleaning: Lightly brushed with a nylon bristle brush during the fresh water rinse followed by air pressure drying.
