ArmaKleen Technical Service Report Summary

Cleaning Trial Type: Polymer removal

Industry: Polymer coating manufacture

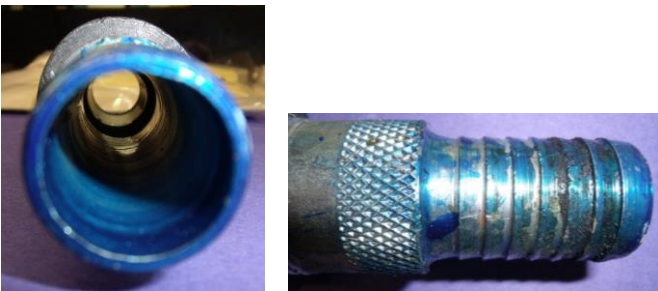
Before Picture

Description of Part(s): Plastic clamp, stainless steel cup, stainless steel cap and stainless steel pipe connectors

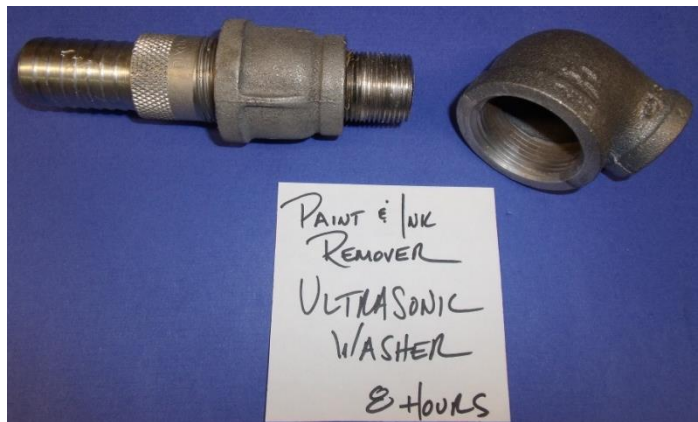
After Picture

Cleaner used: 100% by volume ArmaKleen™ Paint and Ink Remover

Temperature used: 160°F

Time required: 8 hours

Post Cleaning: Fresh water rinse followed by air pressure drying.
